## Dewatering project (2003)

Following the discovery that a large volume of water within the mountain was only being retained by a poor quality concrete dam in the Dyffryn Adda adit a Dewatering Project group was set up.

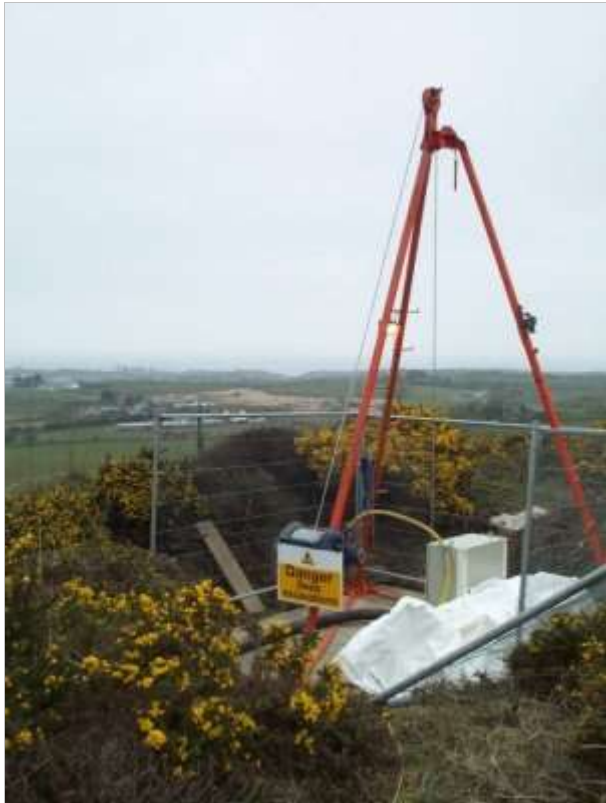
Following discussion it was decided that the safest course of action was to pump out the water from a shaft which had been identified behind the dam. The Cementation civil engineering company were contracted to carry out the work.

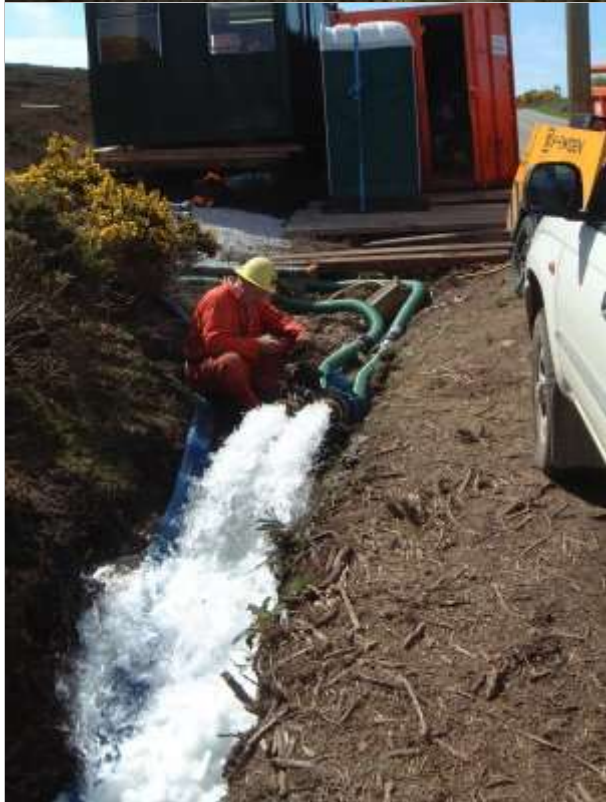
The water was pumped via an existing drainage and settlement system to the Sea at Amlwch Port.

The pumps were capable of removing around 50 litres per second of water from the mountain. In total around 30 million gallons of water was removed.

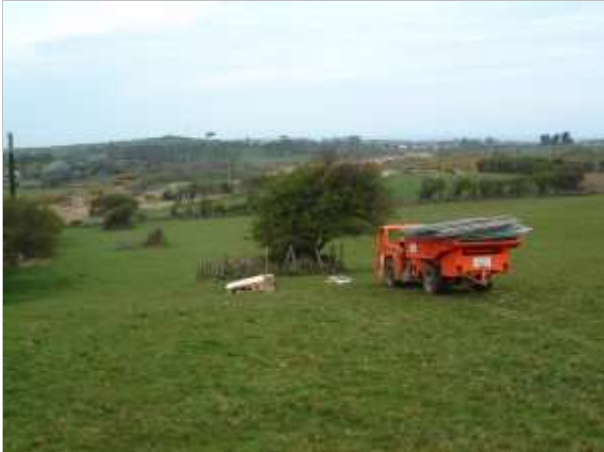
The line of the adit can be seen by these old air shafts in the field.

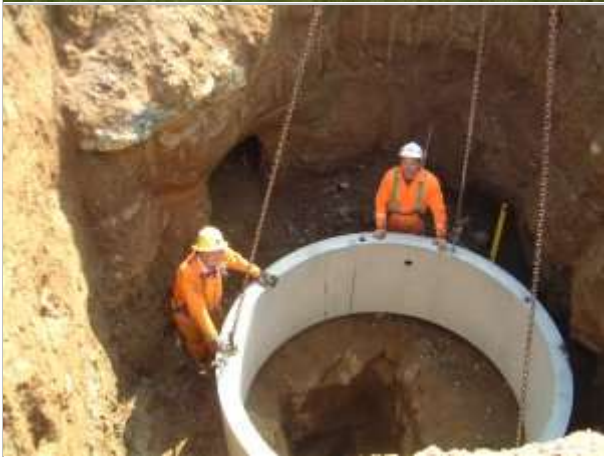
Some of these old air shafts were cleared and made safe. This then allowed the engineers to enter the adit and make a proper assessment of the dam once the water had been removed from the other side of it.

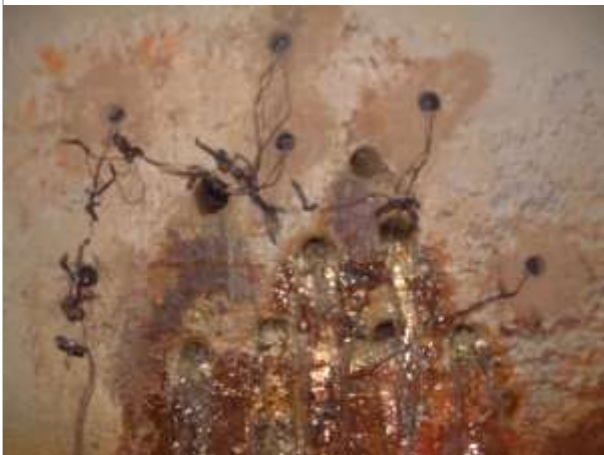
Once safe access to the dam was available a number of test holes were drilled to ensure no significant amount of water was held up behind the dam. A high expansion explosive was then used to destroy the dam.

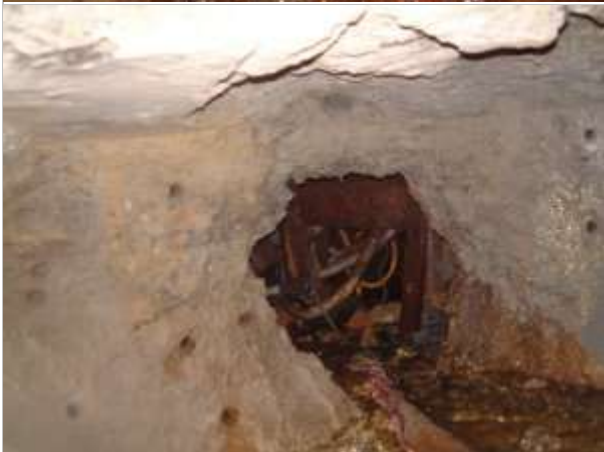
Here the dam has been breached. The build-up of large amounts of debris behind the dam over 60 years can be seen.
